**CITY OF ROCKVILLE HISTORIC DISTRICT COMMISSION
STAFF REPORT**

**February 6, 2001
MEETING NO. 02-01**

APPLICATION: HDC01-0180

411 West Montgomery Avenue

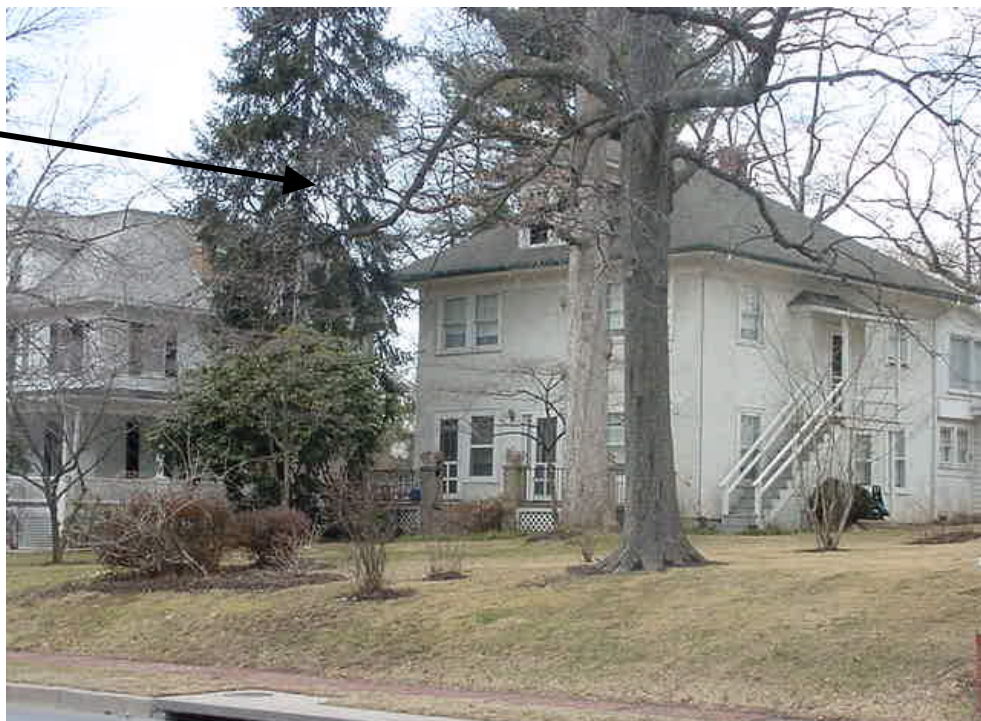
**Spruce
Tree**

The applicant requests a Certificate of Approval to remove a Norway Spruce from the front yard. The tree is approximately 50 feet tall with a trunk diameter of approximately 24 inches and a branch spread of approximately 16 feet. The main trunk of the tree is located 4.5 feet from the edge of the front porch and branches overhang the front porch decking by about 3 feet.

In addition, the soil and root mass of the tree is mounded above the soil level under the porch and causes water to flow under the porch into the cellar during heavy rain, according to the owner.

The City Forester is in agreement with the applicant that the tree could cause damage to the roof and porch. The applicant has planted numerous other trees on the property and he intends to restore the front porch to its original design in the future in which case the tree would have to be severely trimmed or removed. However, the tree is healthy and does add to the character of the neighborhood.

STAFF RECOMMENDATION: Staff recommends approval for removal of the Norway Spruce as it is located very close to the house and could potentially cause damage. Severe pruning of the tree may be feasible as an alternative but this would not alleviate the problem of water flowing under the porch and into the cellar.
